Highway 71/72 Refinery Site
Bossier City, Louisiana
Lead Removal Action
Fall/Winter 1996

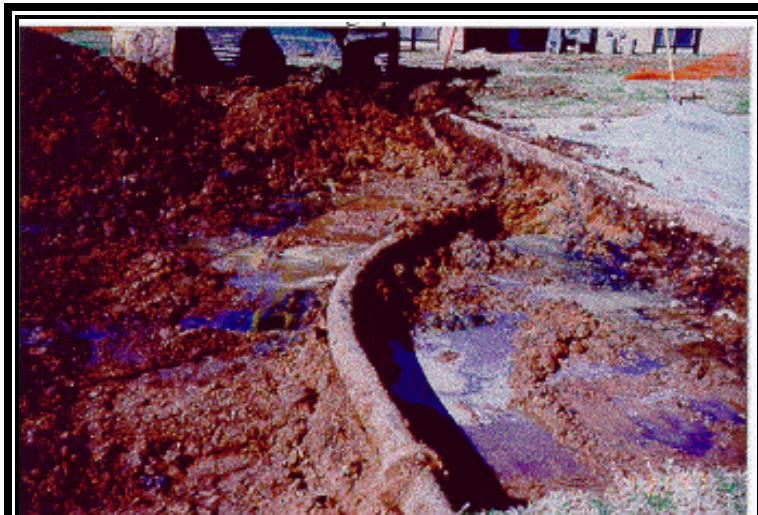
Photograph #1 - Removal area #13 - buried, abandoned pipe (6 inch diameter) was uncovered during excavation.

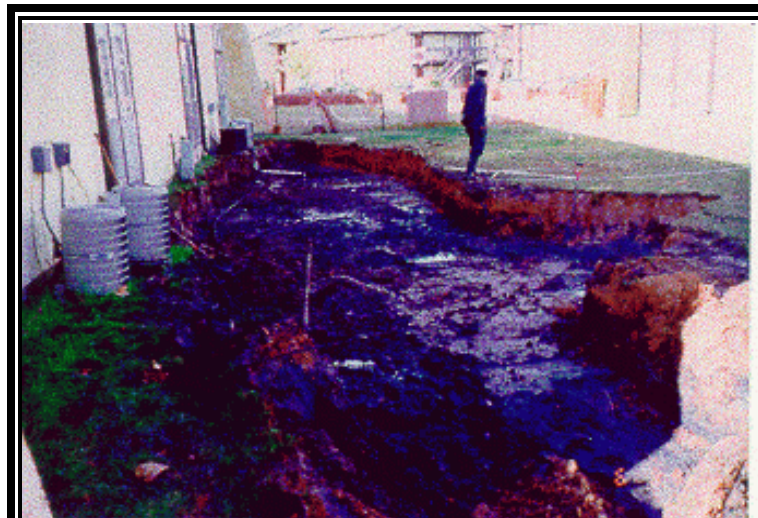
Photograph #2 - This photo shows a portion of removal area 10. The black material in the excavated area is a coke-like material that was been wetted. A broken water pipe from excavation activities caused the wet conditions.

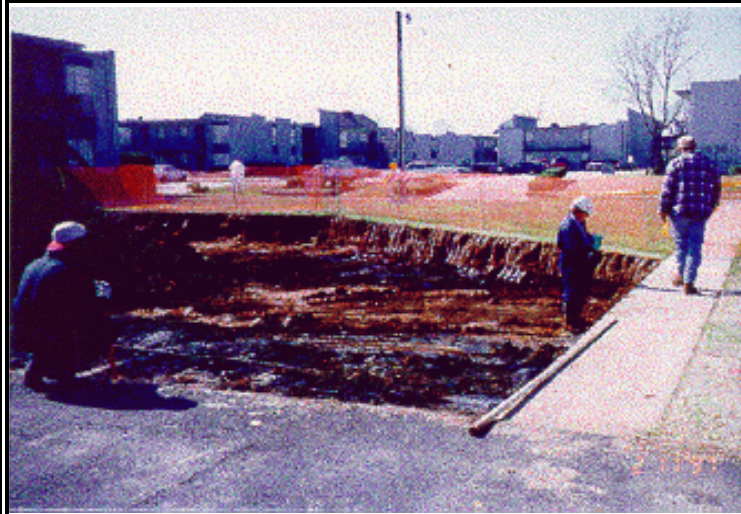
Photograph #3 - Removal area #3 - Black, coke-like material observed in this excavation.

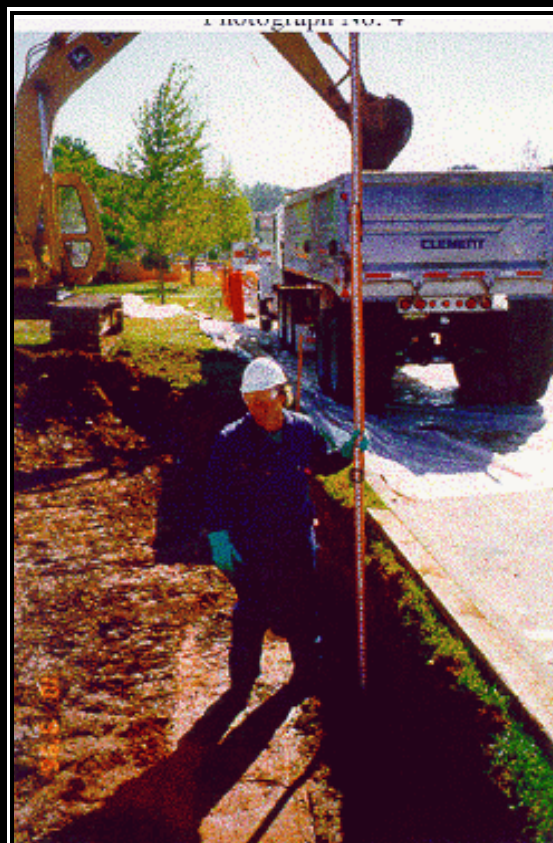
Photograph #4 - This photograph shows part of removal area B. In the foreground, a member of the survey crew is measuring the removal depth. In the background, a track-hoe is loading contaminated soil into a haul truck for transportation to an approved landfill.

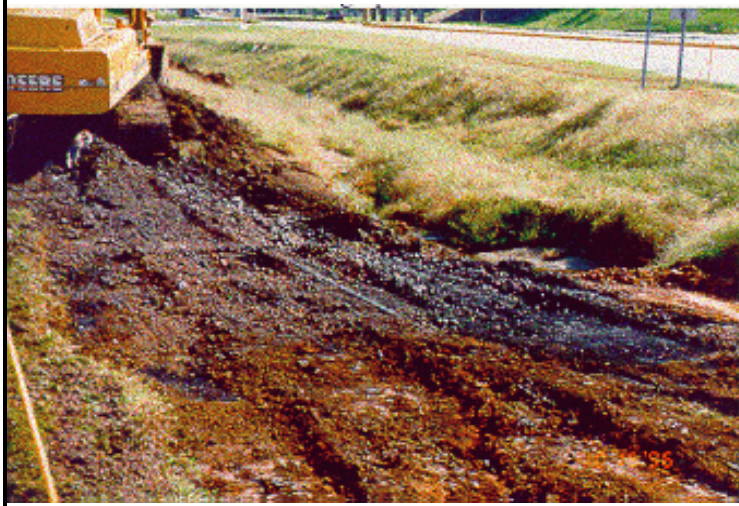
Photograph #5 - This photo shows part of removal area C, near the intersection of Old Minden Road and Interstate 20. Excavation continued down the embankment removing much of the surficial coke material.
